WROUGHT IRON *for* UNDERGROUND SERVICES

A TECHNICAL BULLETIN PREPARED BY THE ENGINEERING SERVICE DEPARTMENT

A. M. BYERS COMPANY • PITTSBURGH, PA.

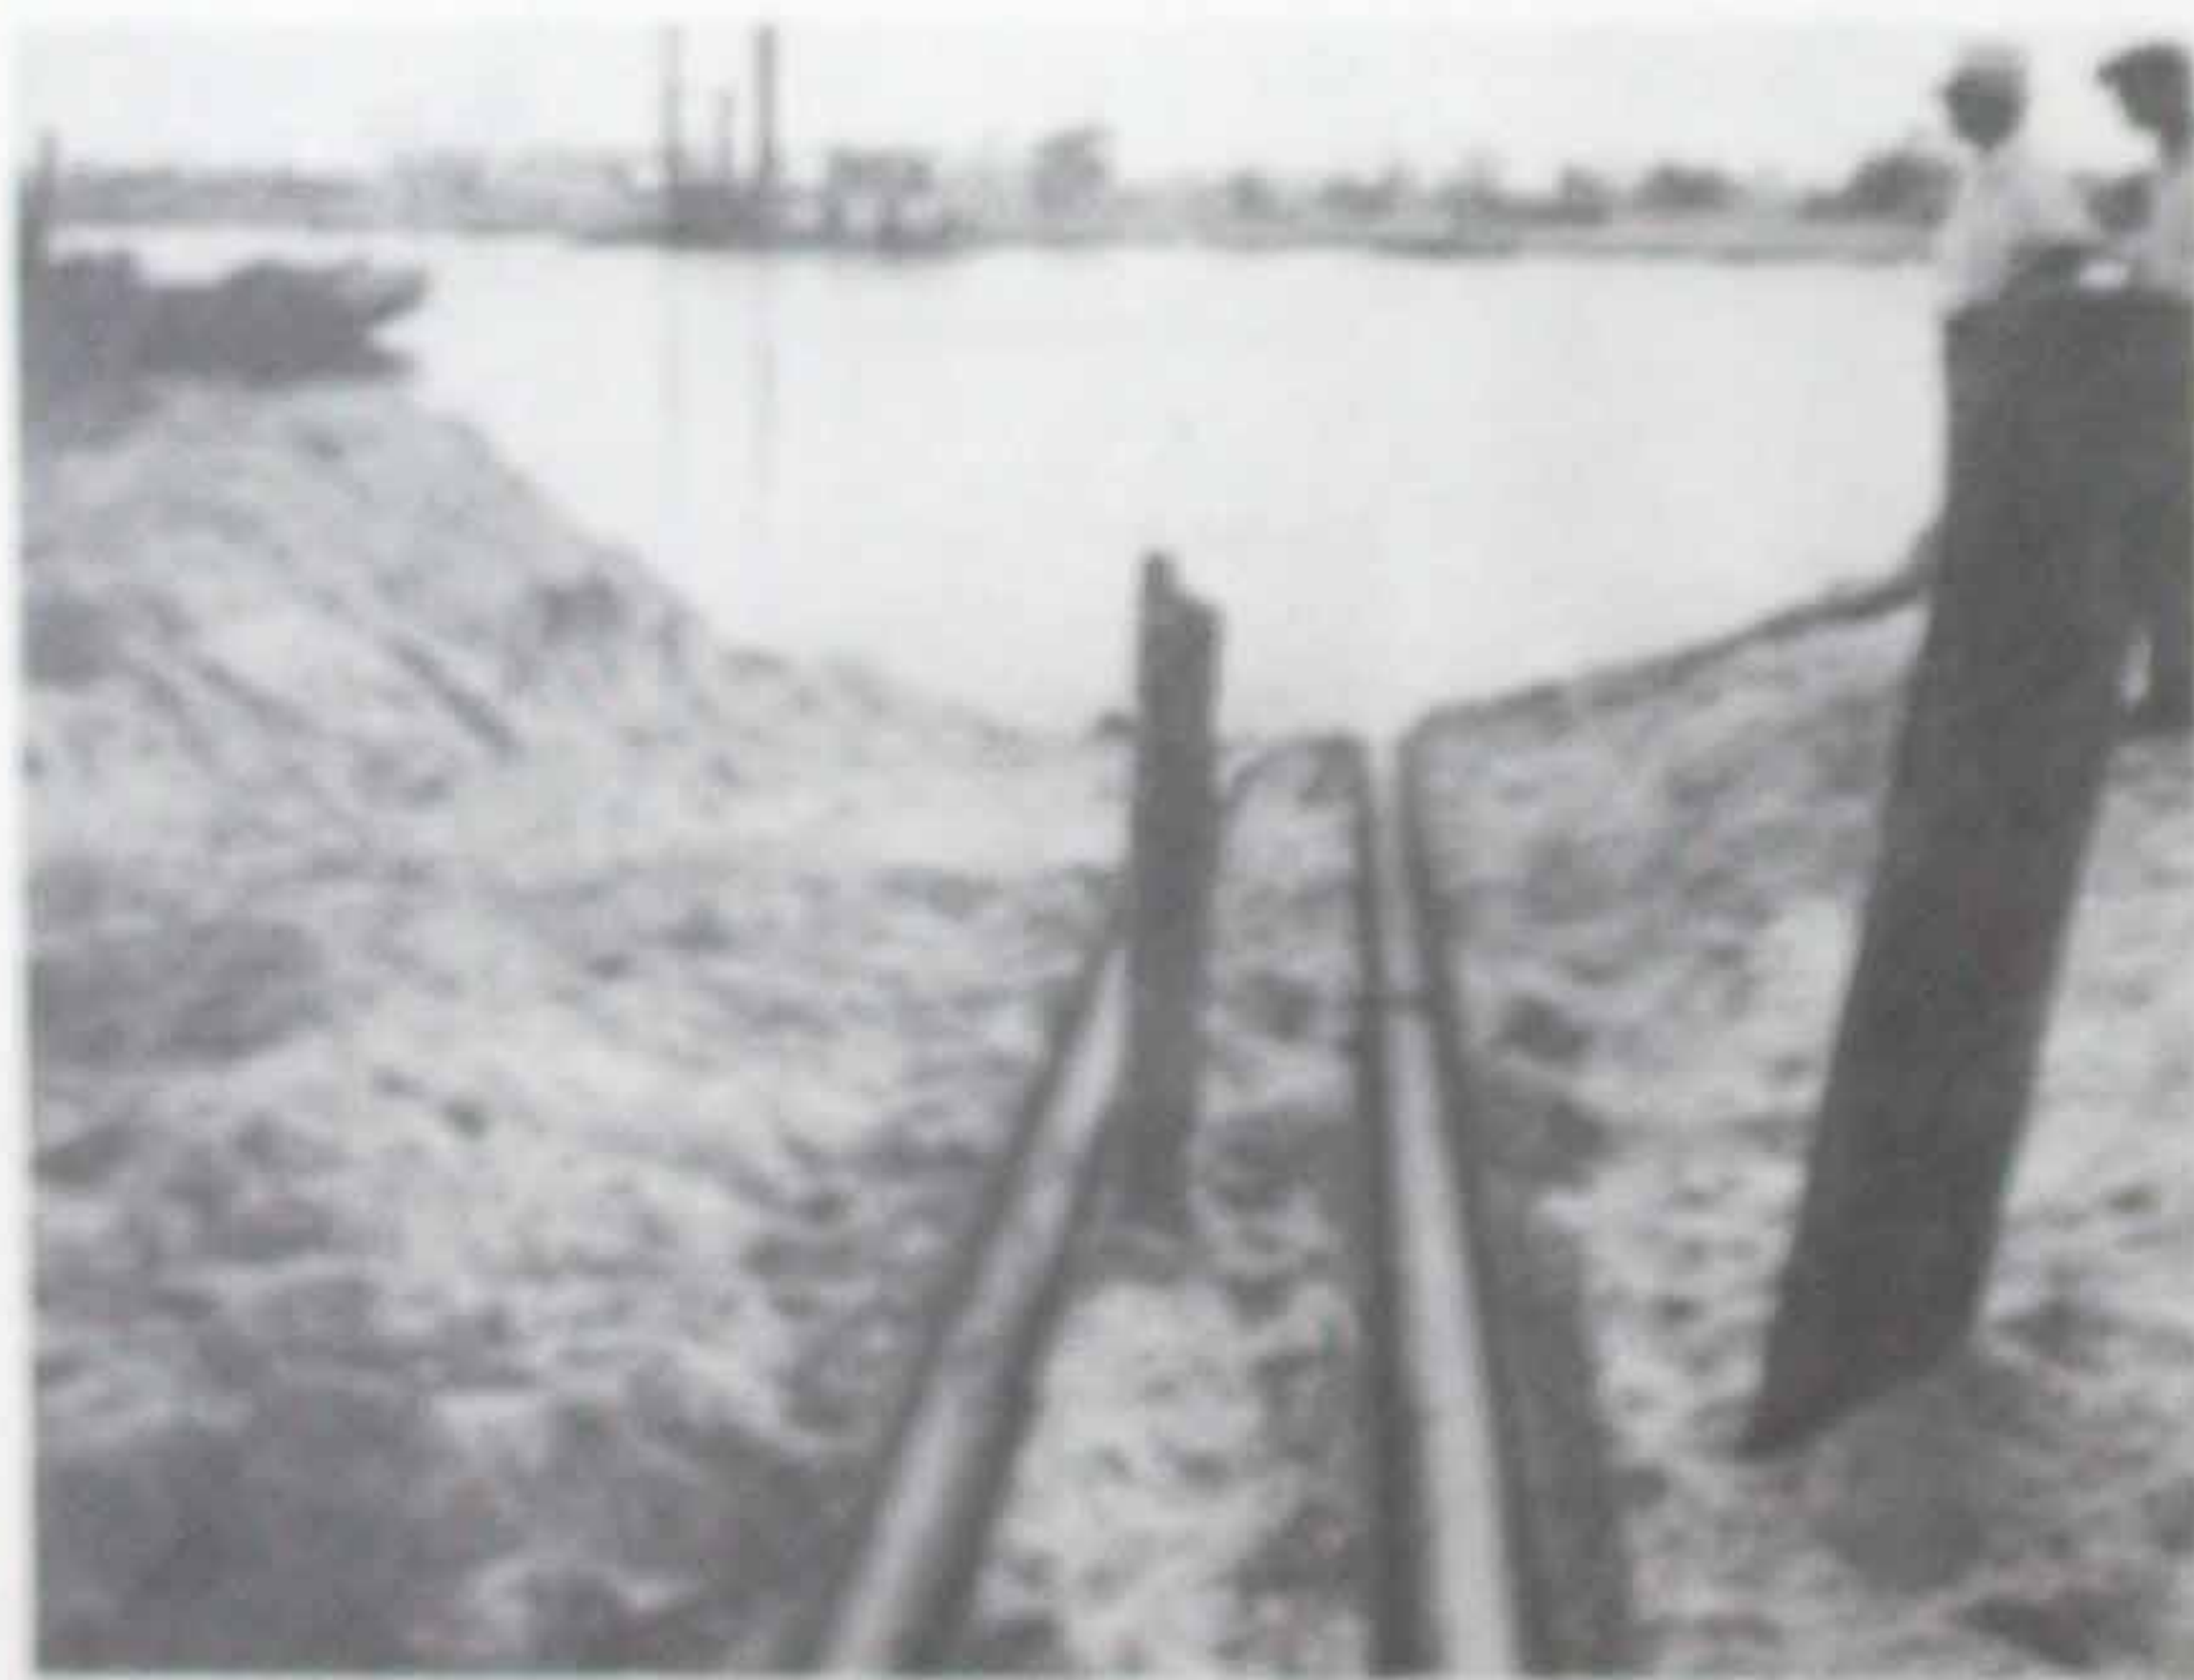
Fig. 32 shows two lines of 6" wrought iron pipe, with welded joints, being installed near Houston, Texas. They cross the Houston Ship Channel and lie in a trench eleven feet deep dredged in the bottom of the channel. Galveston Bay, an arm of the Gulf of Mexico, lies adjacent to the body of water shown in the photograph, and so the pipe is exposed to the corrosive action of soil saturated with sea water.¹¹

Two steel lines, formerly used, failed after 8 and 10 years service, respectively, and were removed. The wrought iron lines have been in service over nine years, and according to the Division Superintendent in charge, they have never given any trouble at all.

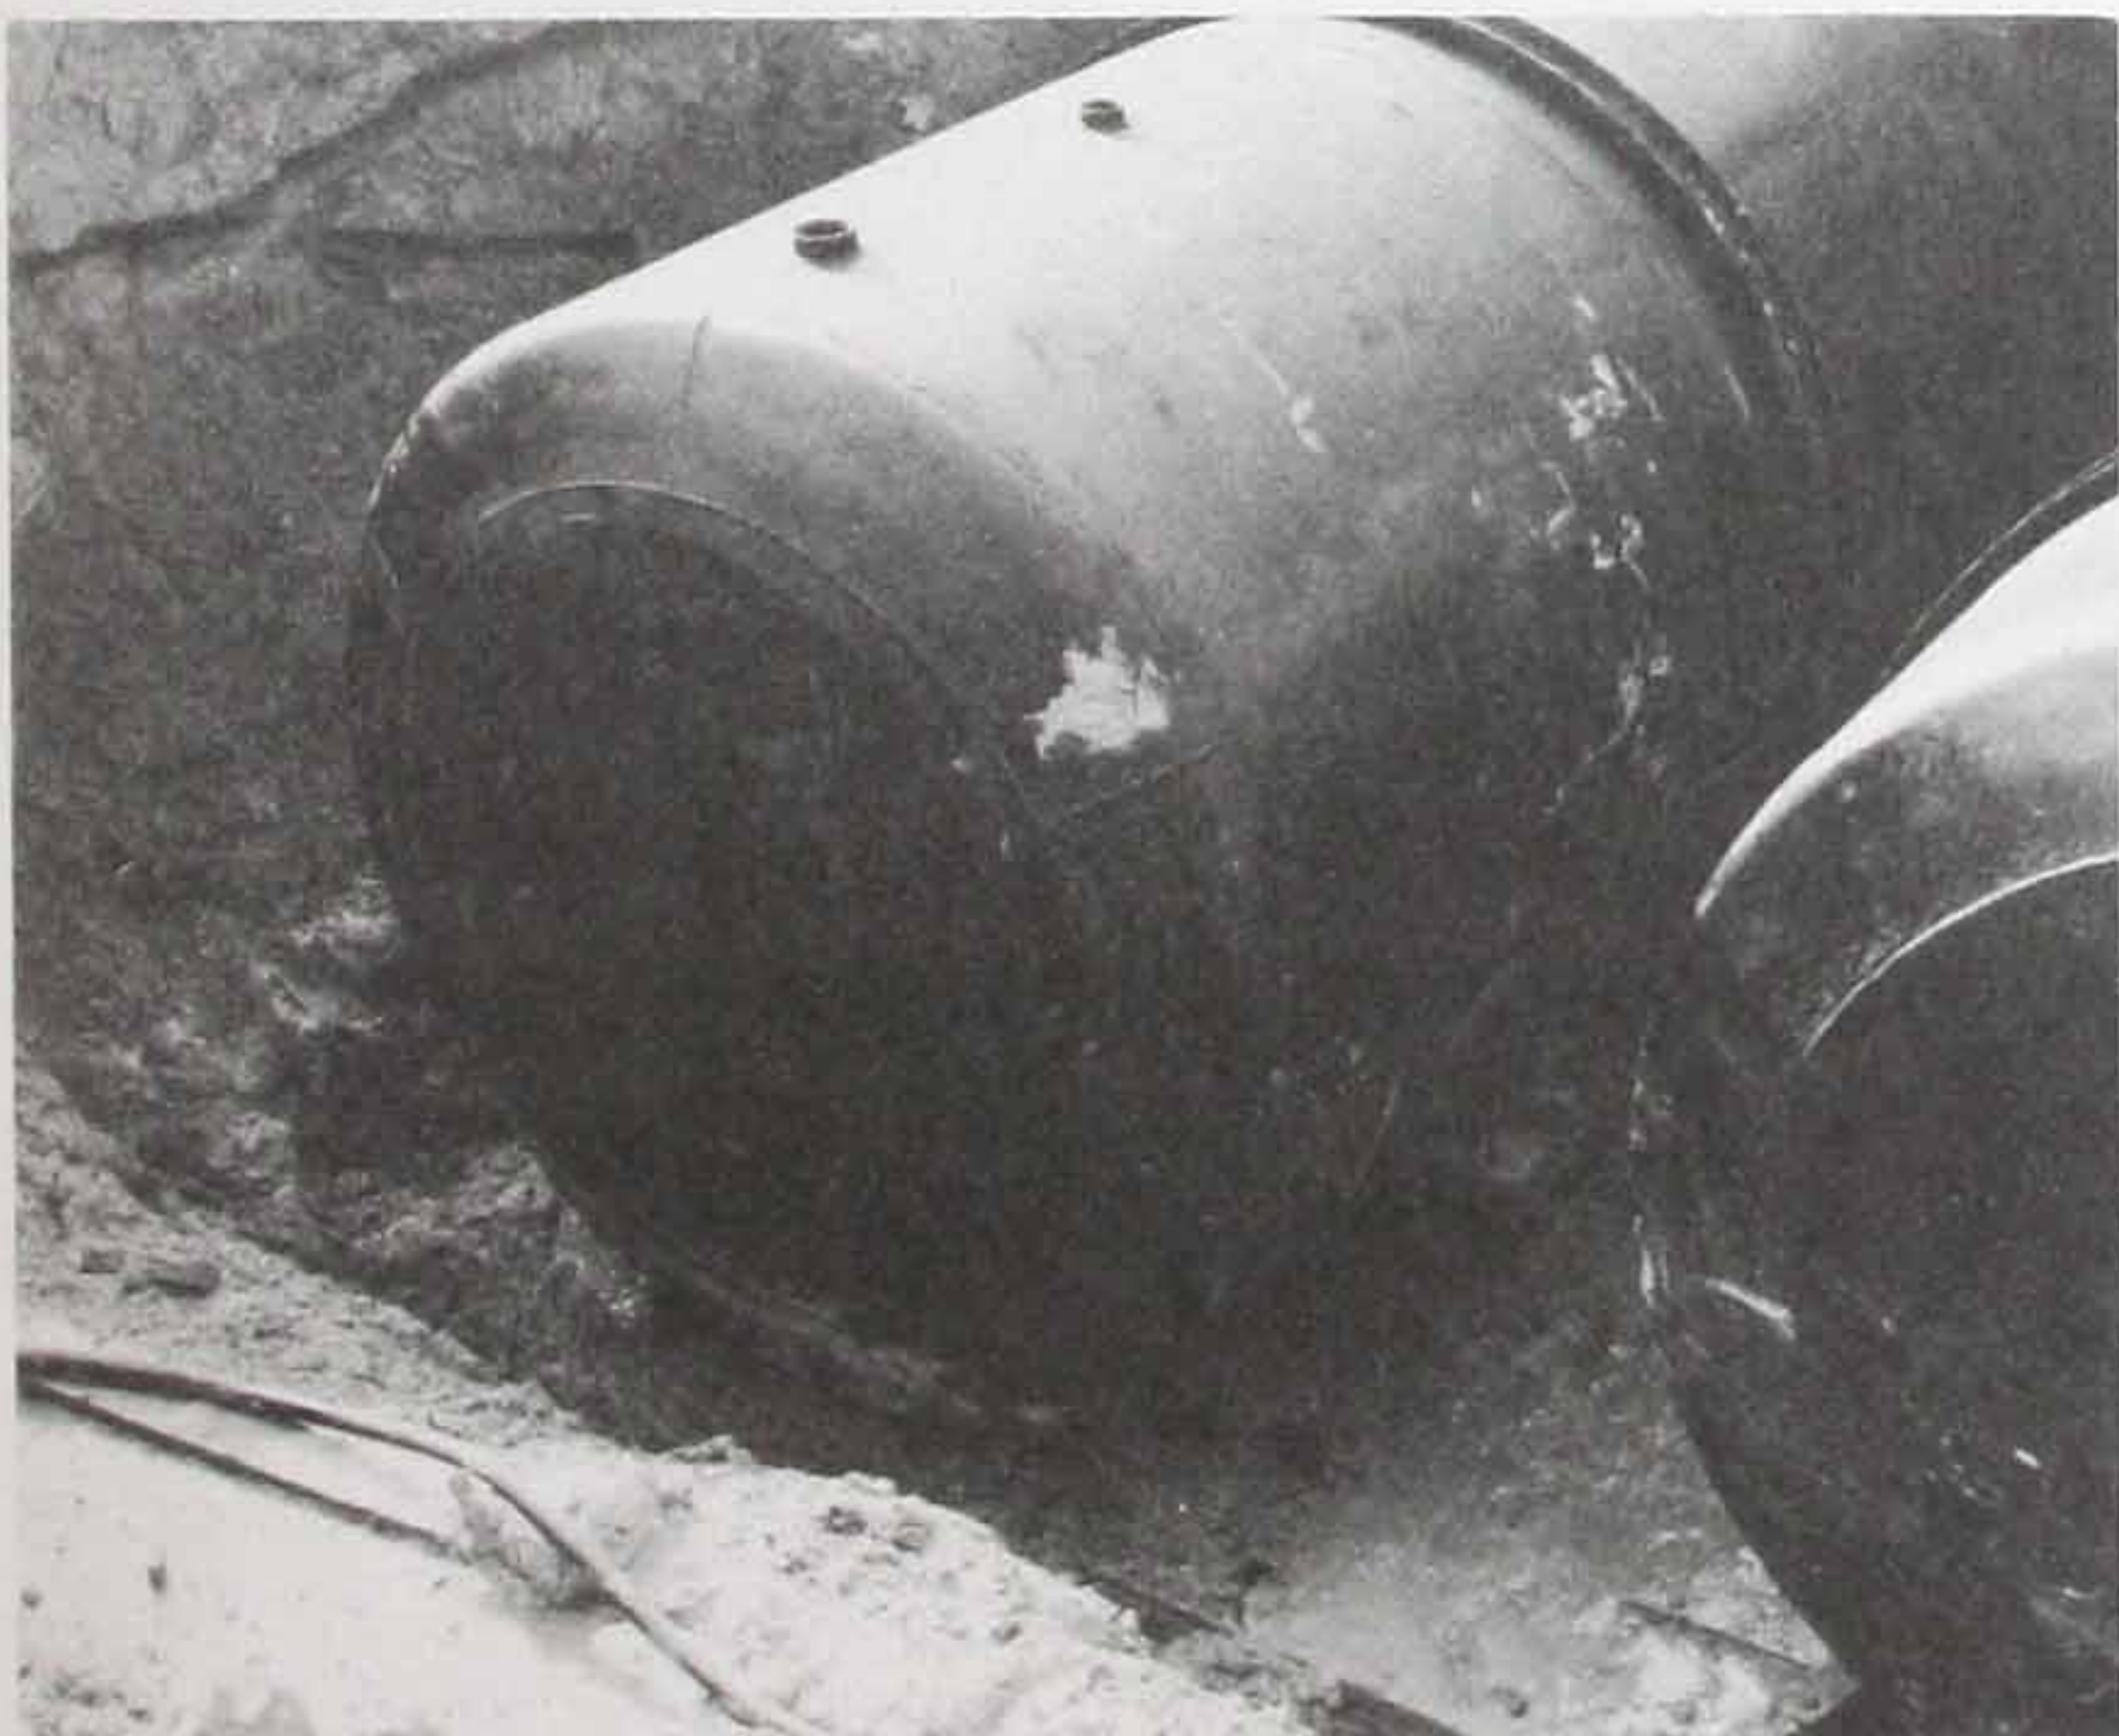
recently installed. They are shown in Fig. 41 and were fabricated from $\frac{3}{8}$ " genuine wrought iron plates by Oldman Boiler Works, Inc., in Buffalo. The method of fabrication of the heads can be seen in Fig. 42.

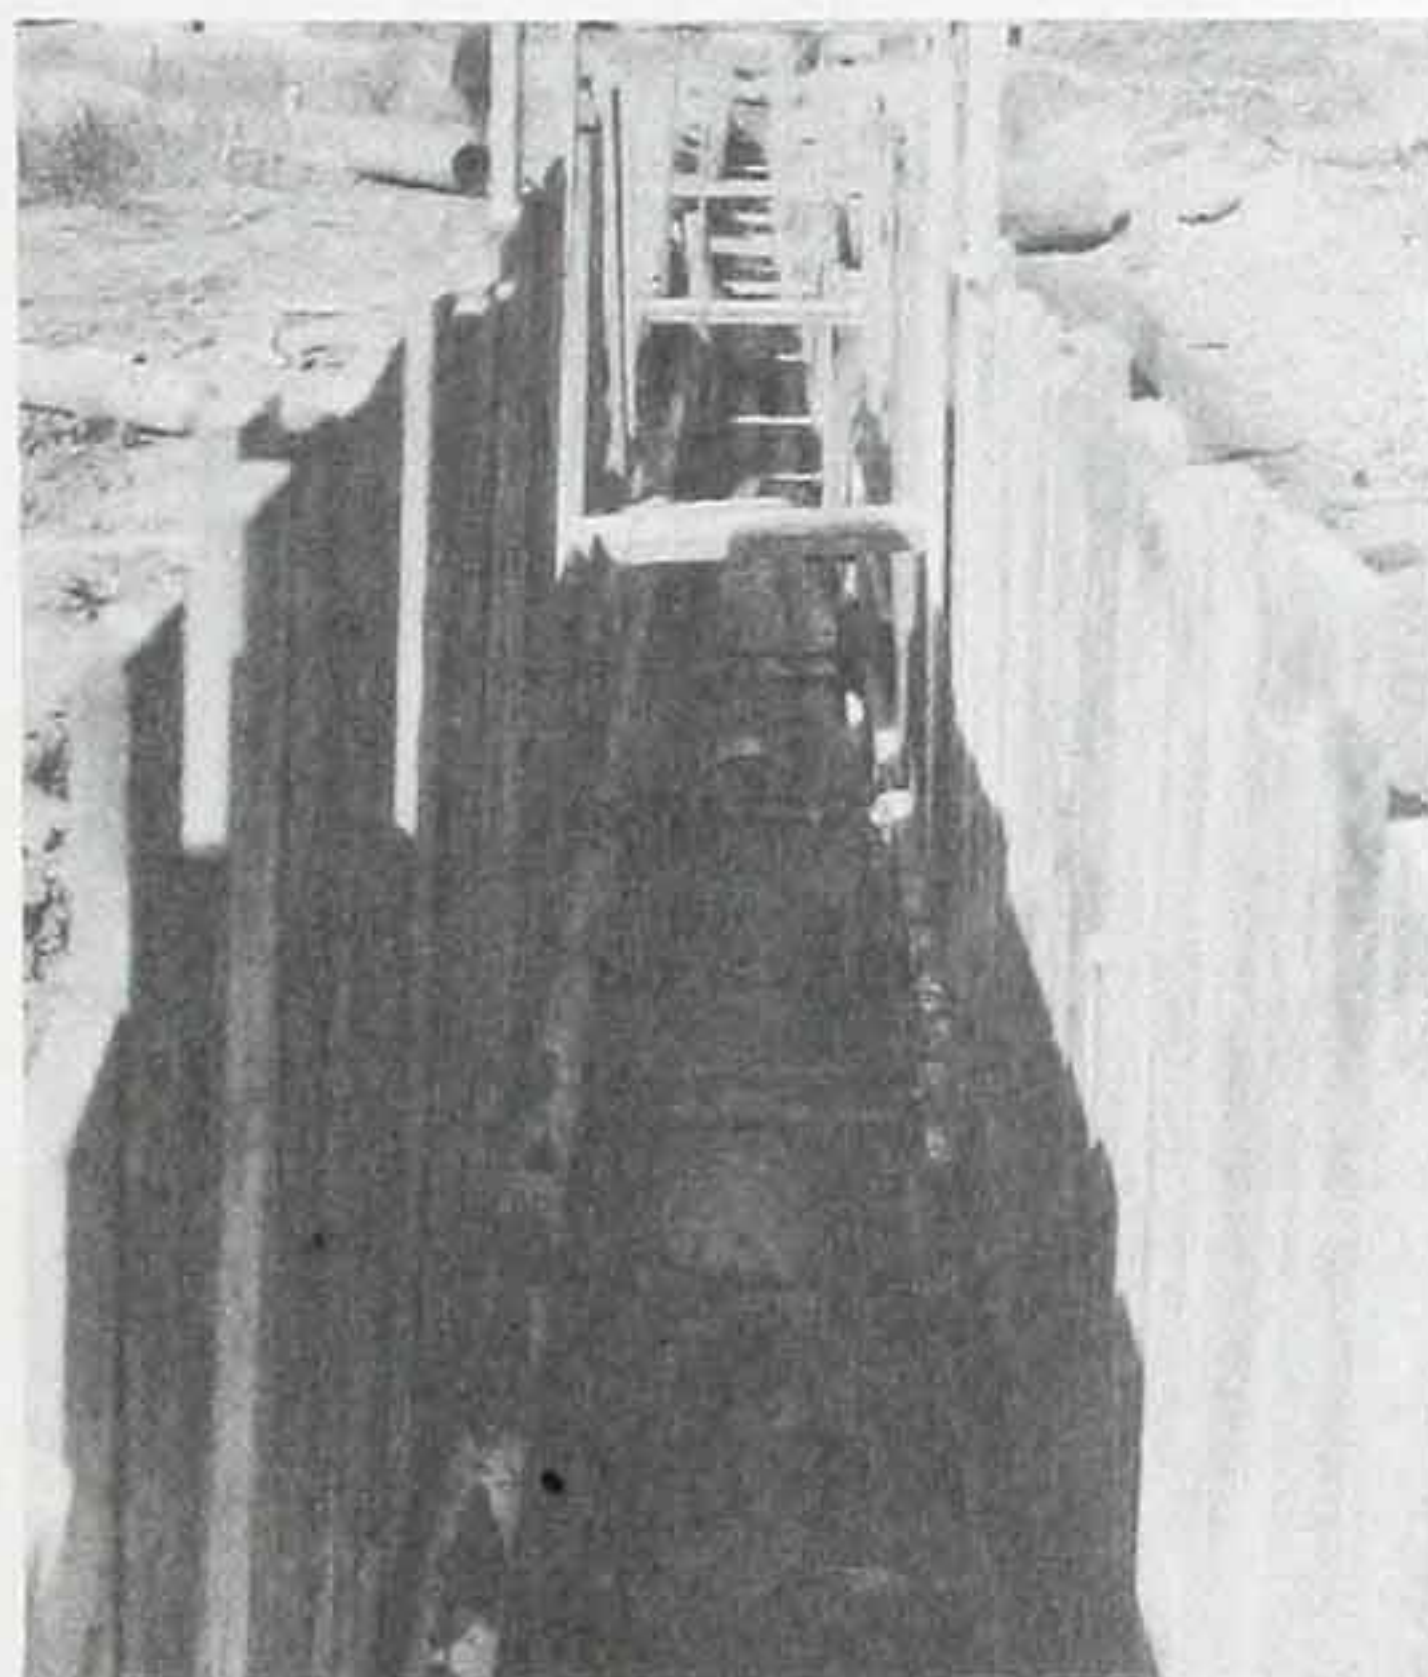
Since the middle 1920's, when the residential village of Mariemont, near Cincinnati, Ohio, was constructed by the Thomas J. Emory Memorial, a central steam distribution system has been in service. Fig. 44 shows one of the steam mains being welded, prior to application of insulation consisting of two layers of asbestos, one of bright tin, and several inches of wood. Tar-paper was placed over the insulated pipe before the trench was back-filled. The insulated main, ready for the backfill, is shown in Fig. 45.

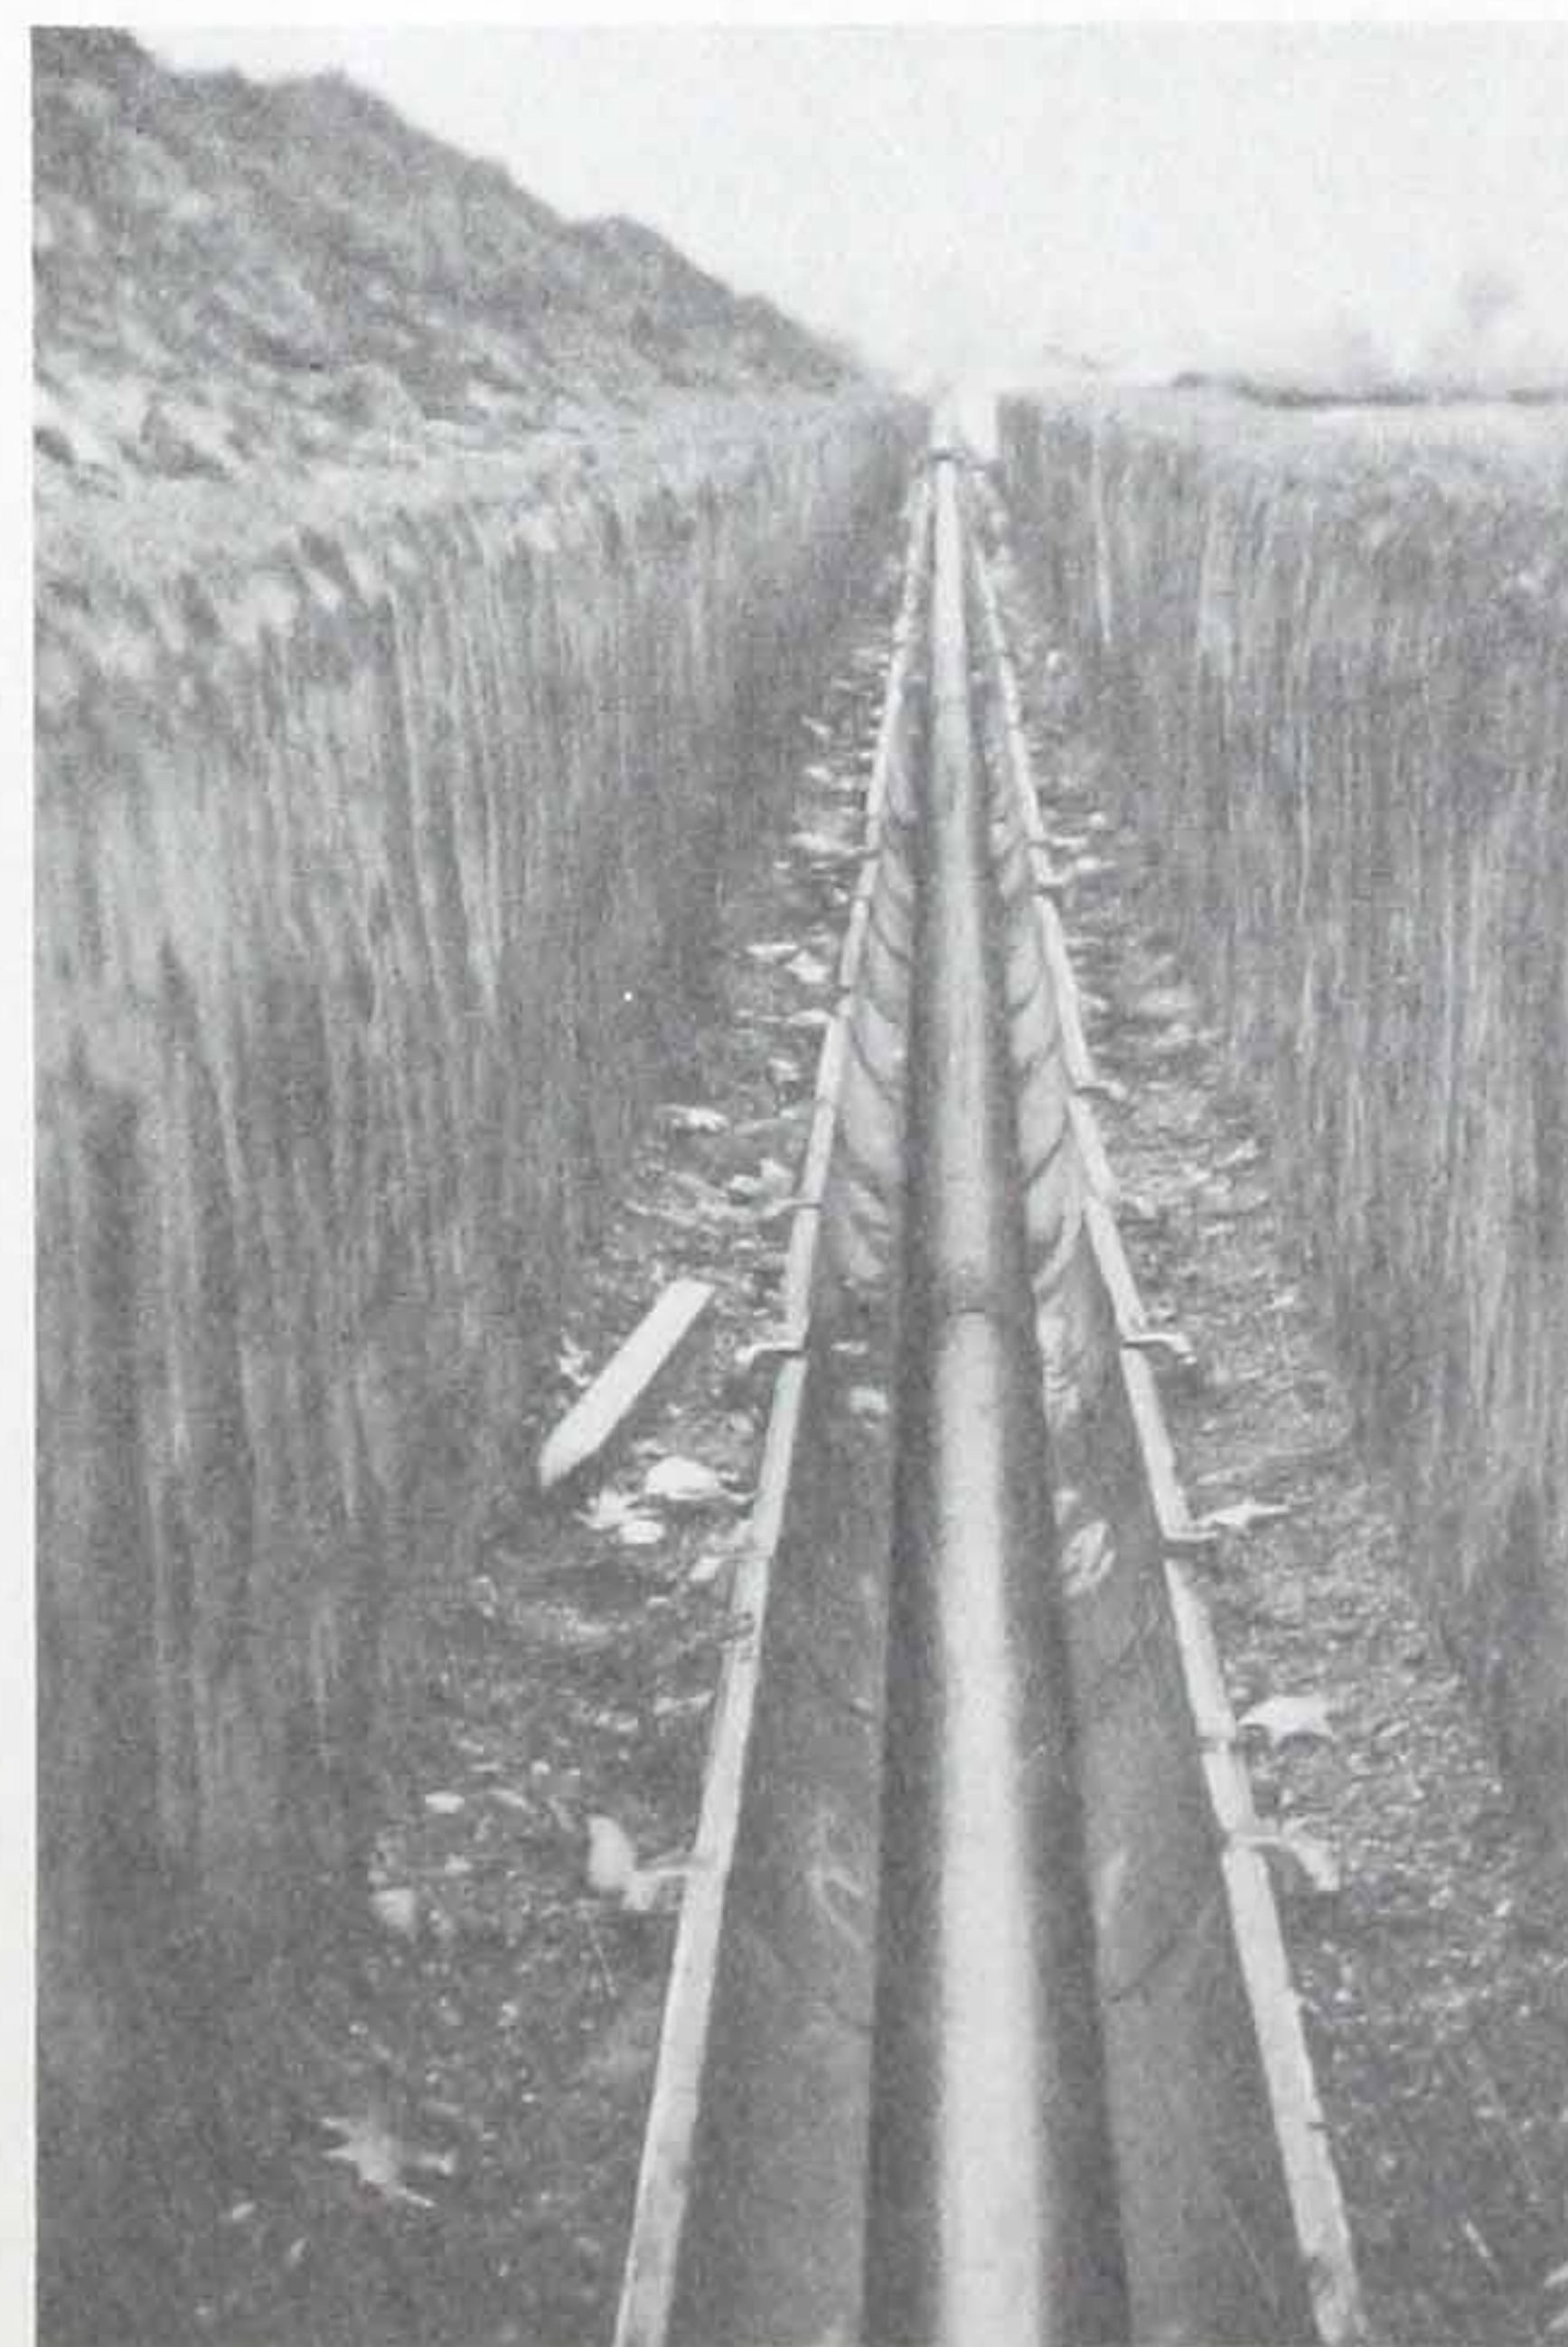
Practically all the original wrought iron pipe is still in use. Fig. 48 shows wrought iron pipe being installed in a recent addition to Dartmouth's steam system, when an asbestos-insulated line was run to the new Physics Building.

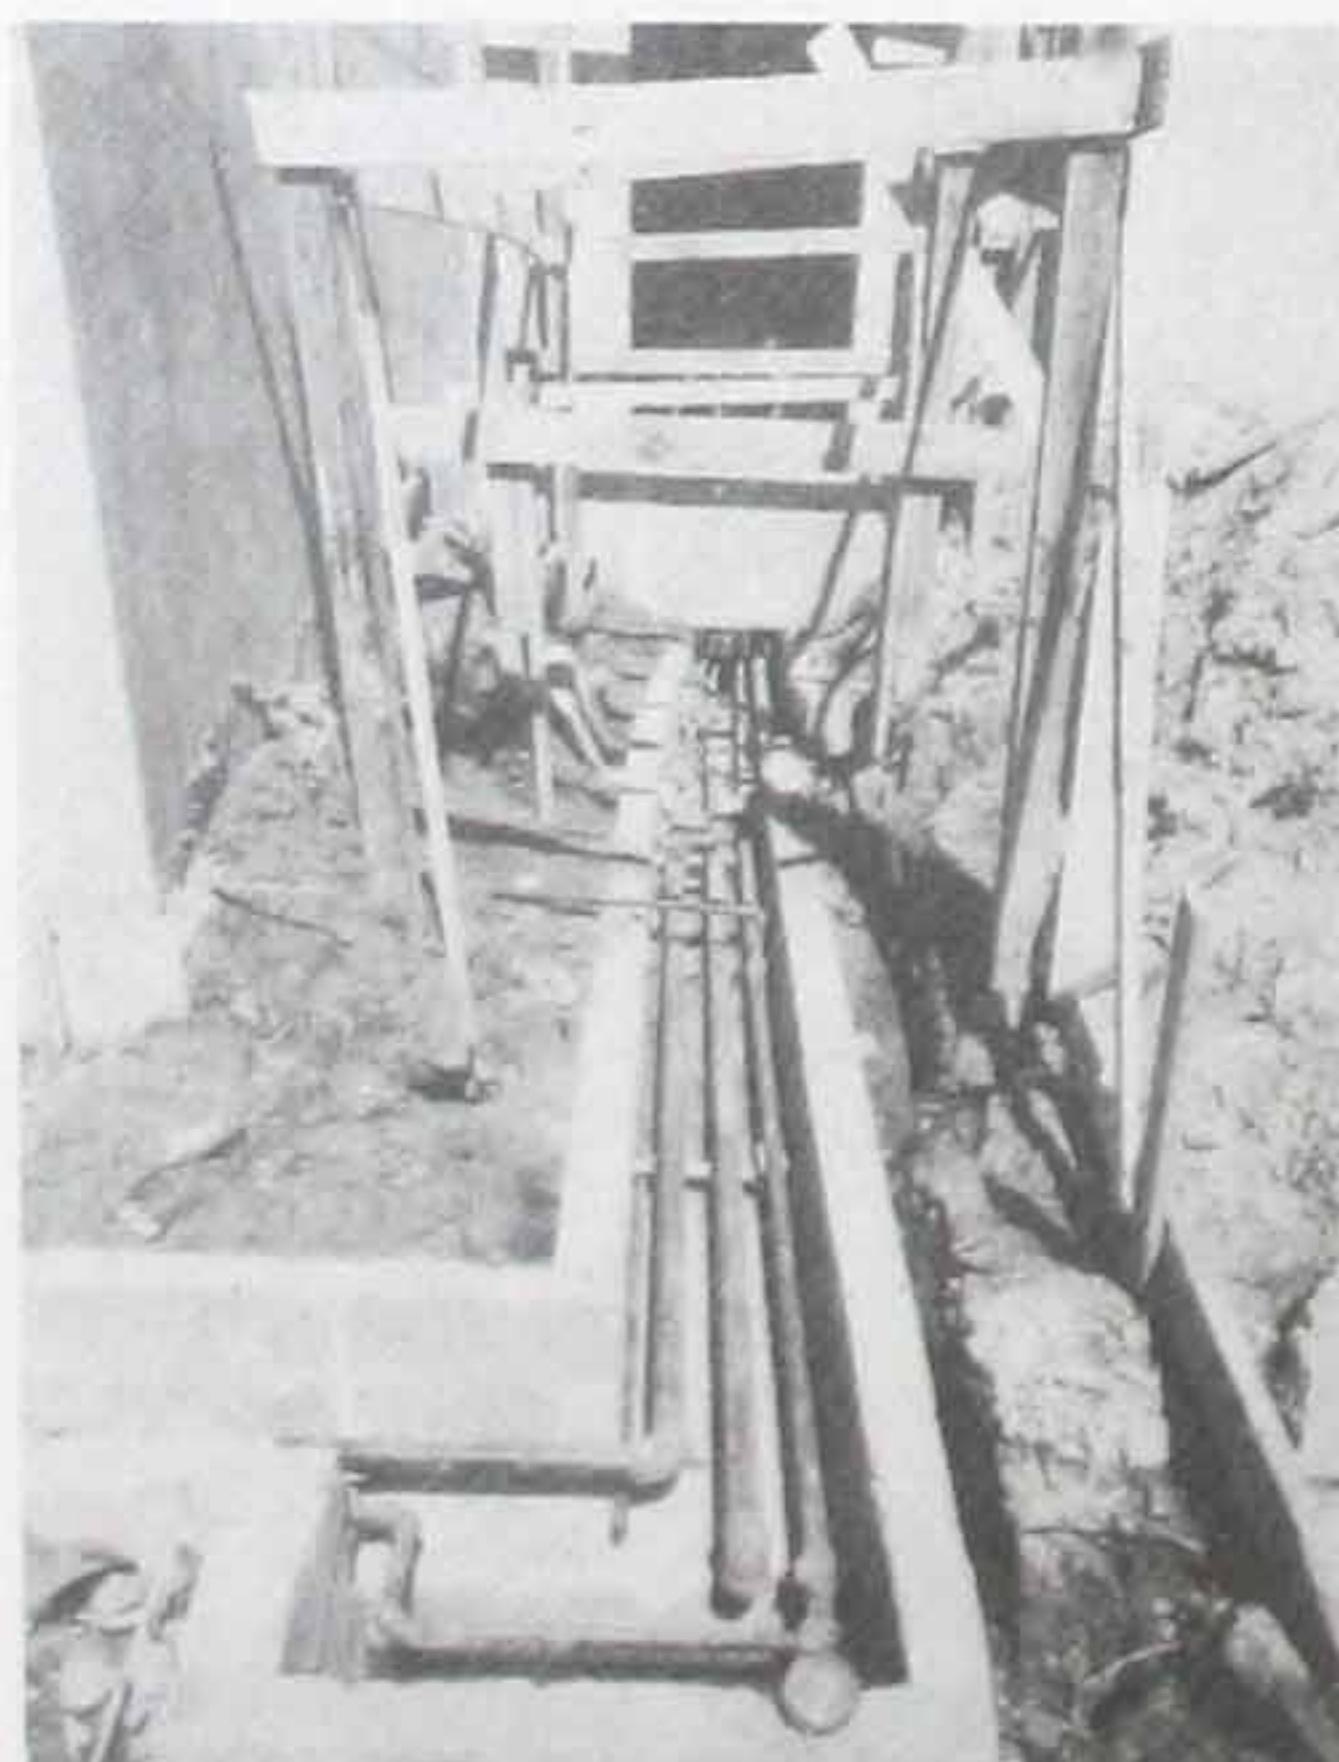
for all tunnel piping. Part of the installation is shown in Fig. 51 shortly before the tunnel was covered.

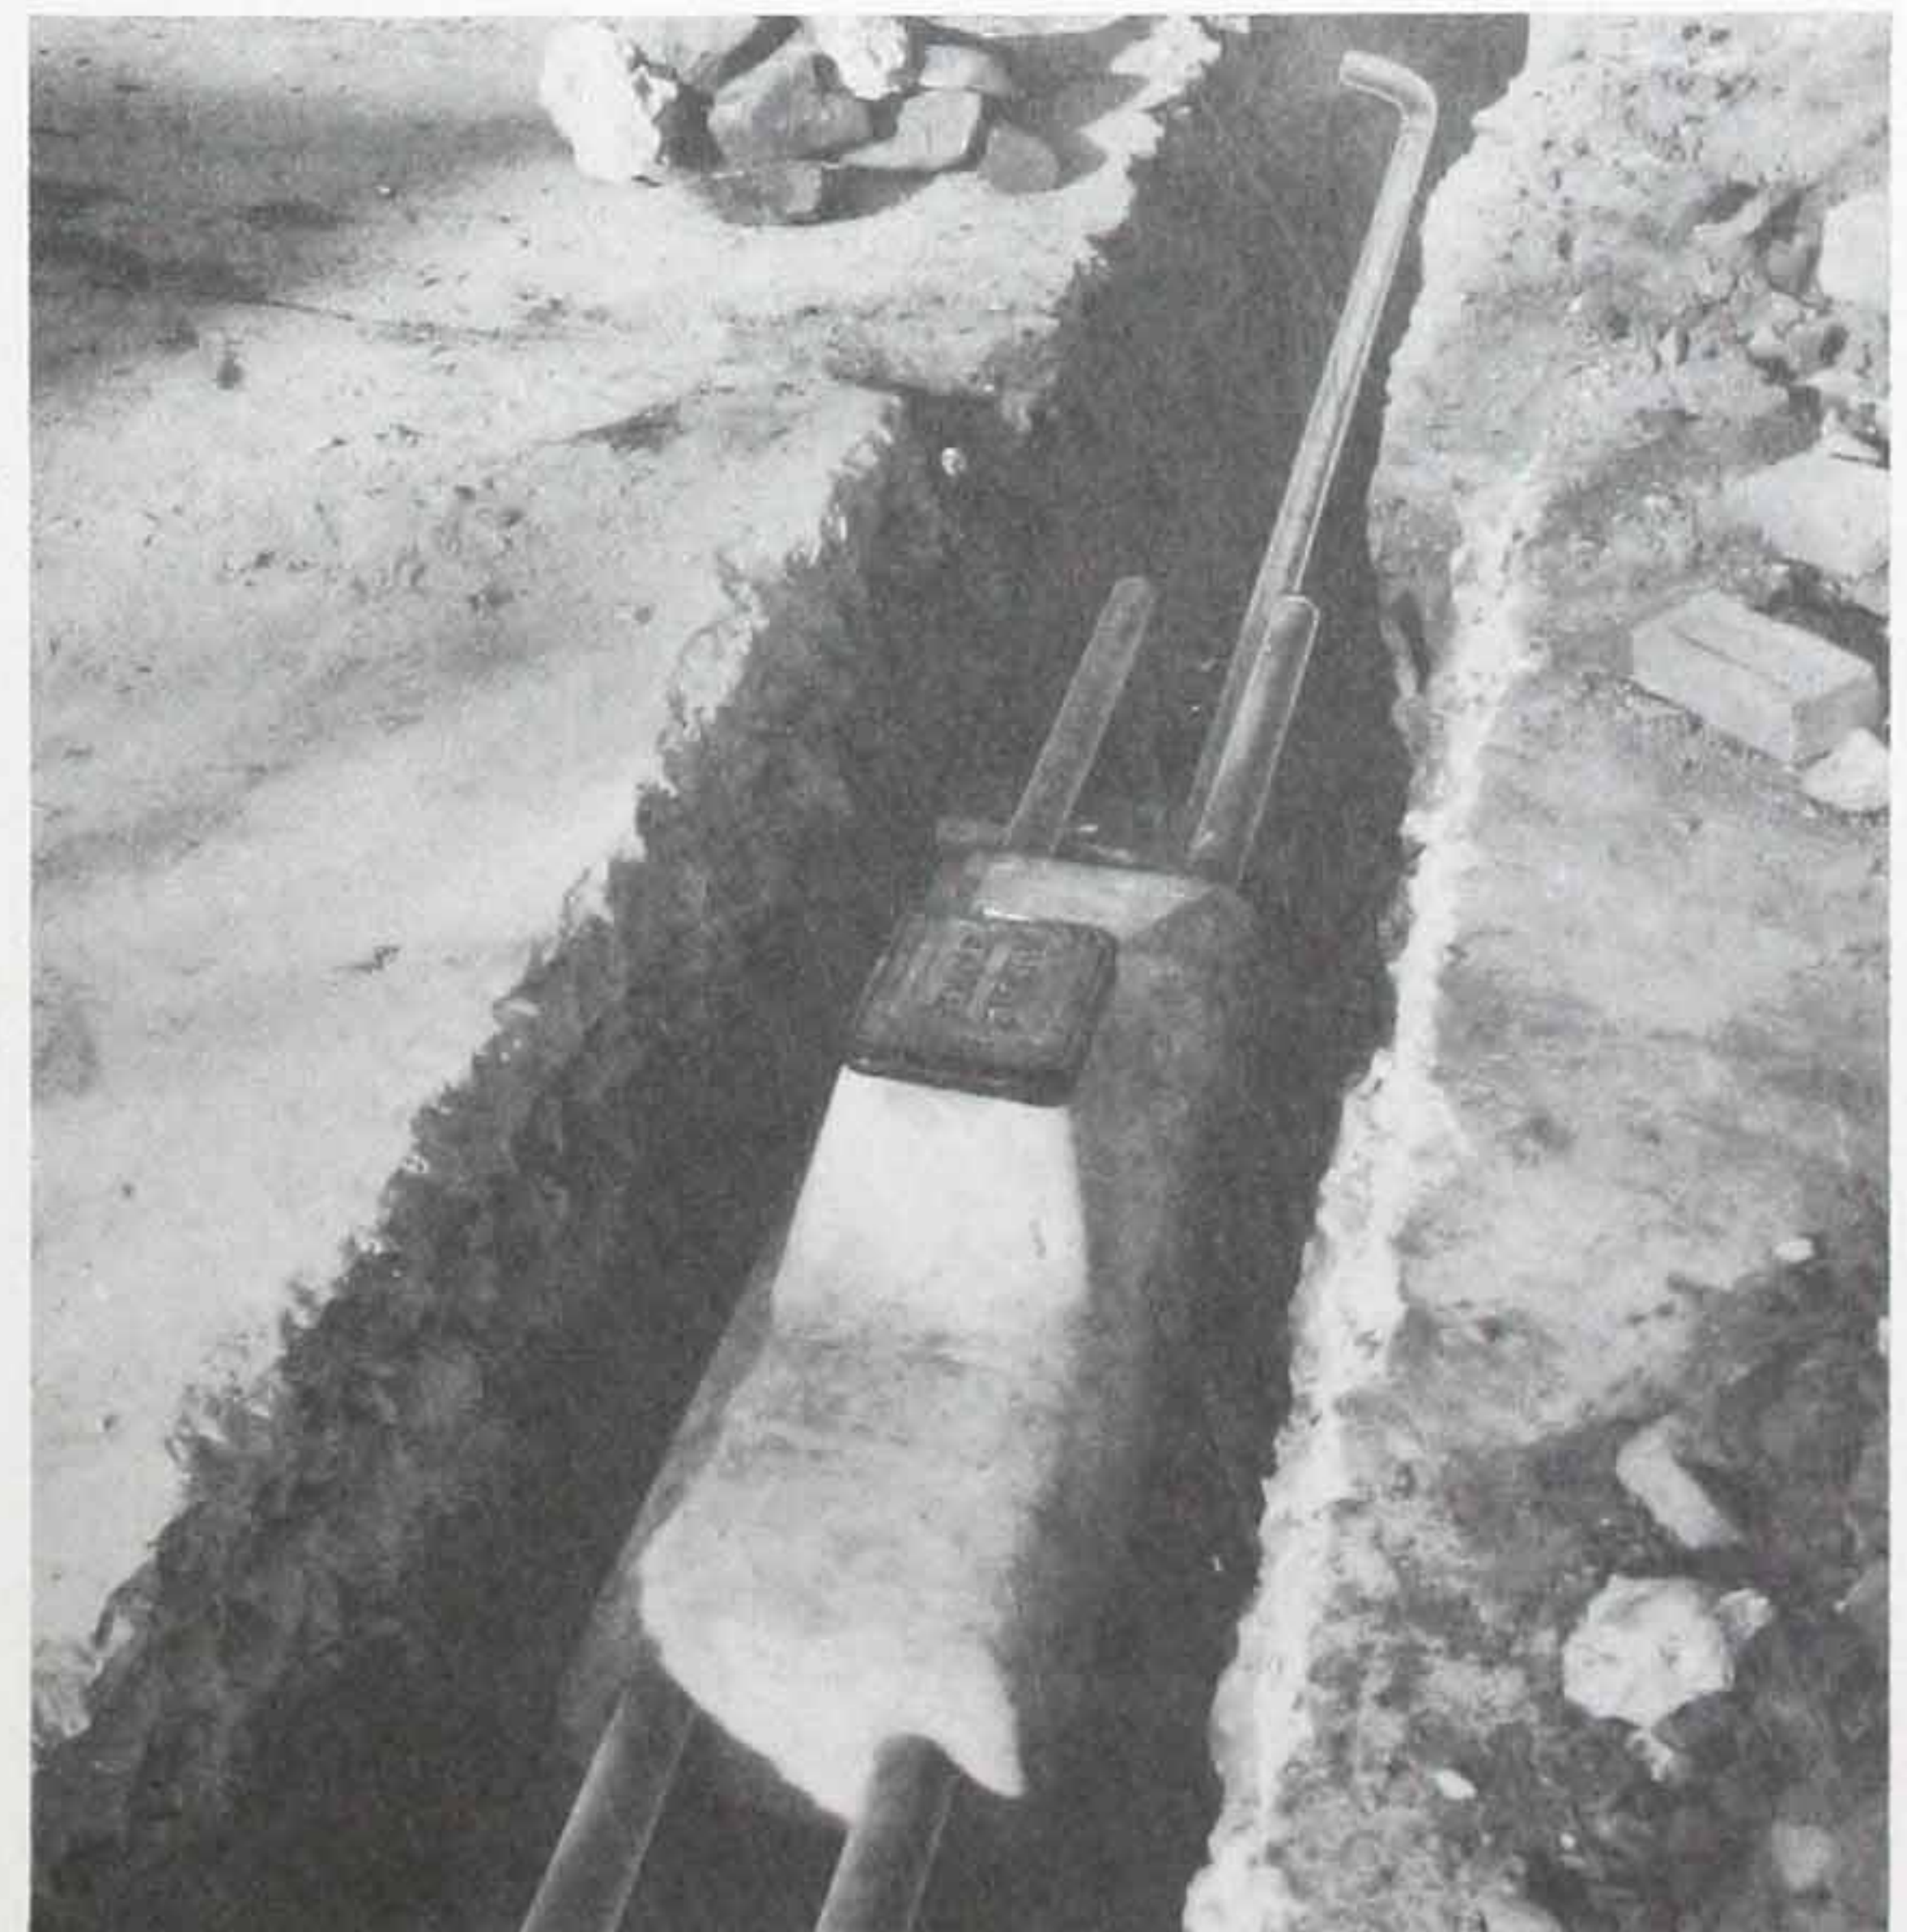
devices are actuated by the magnetic effect produced as a vehicle moves over them, and they are used to change signal lights where it is necessary to admit cars to main highways from side roads. When the car passes over the detector, the signal light changes, stopping traffic on the main artery for 20 seconds. Fig. 55 shows a unit being installed, and the conduit leading to the signal can be seen in the background.
